# Transforming Buildings

Grand new buildings may grab the eye and the headlines, but it is often in the transformation of existing buildings that the engineer can make the biggest difference – by helping to create something inspiring from a building which has outlived its use, or simply by making the building function more effectively.

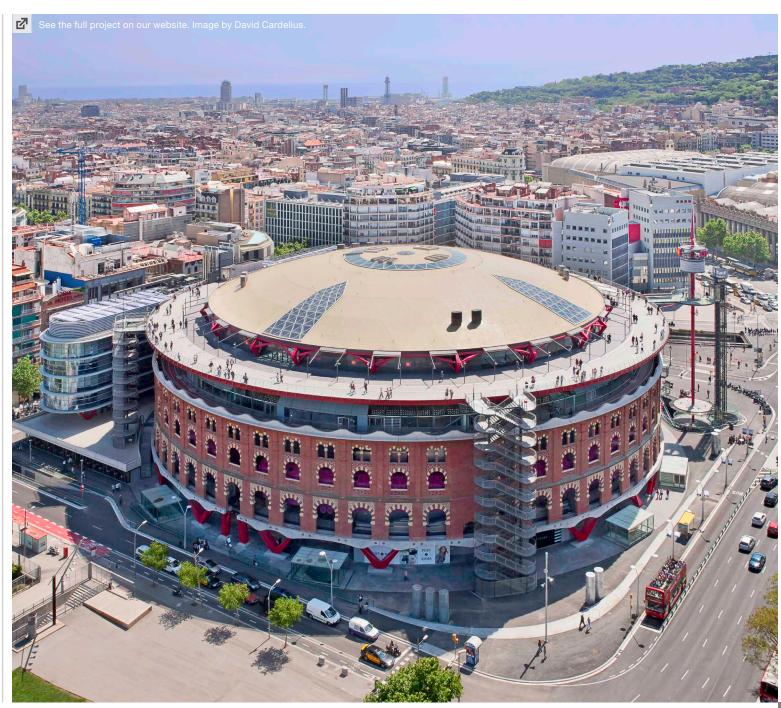
MASONRY FAÇADE
SPRING CONNECTIONS
RADIAL BEARINGS
CAPPING BEAM
ARCHED RING BEAMS
STIFF ARMS/NEEDLES
V-PIER SUPPORTS
WALKWAYS
PRESTRESSED TIE
RESTRAINT FIXING
STRUT/HANGER

**Right:** The main above ground components of Las Arenas: a timber dome, a steel dish, retail pods and the retained facade.

The walls were clamped at the base by a pair of arched concrete ring beams, and the whole edifice delicately supported on a new system of steel V-piers, providing clear access beneath from every direction.

A series of new perimeter walkways at various levels reinstated lateral support to the original walls. Careful planning of the demolition and construction sequence, with safe support maintained at all times, was critical.

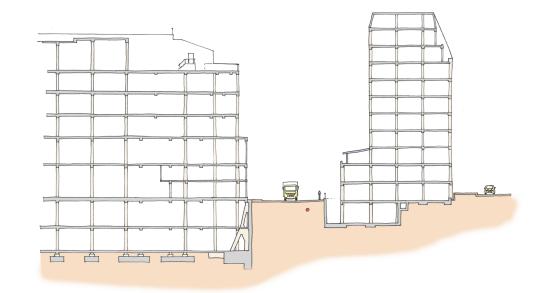
It also meant that Expedition needed to have a representative on site most of the time, to spot immediately if anything uncovered by the works was found to be other than expected. **Top:** The 50m bridge supporting the new goods ramp in construction.

The major elements of the new works included the design and build-sequence for a complex steel truss forming a 50m-long sloping, underground bridge which carries the new lorry exit ramp, and a new escalator and lobby connecting the ground floor of the newly-acquired office building with the lower basement of the store, passing under the mews along the north side of Selfridges and under the new bridge.

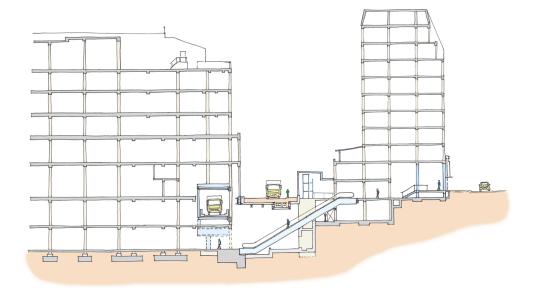
Above: The new goods ramp completed.

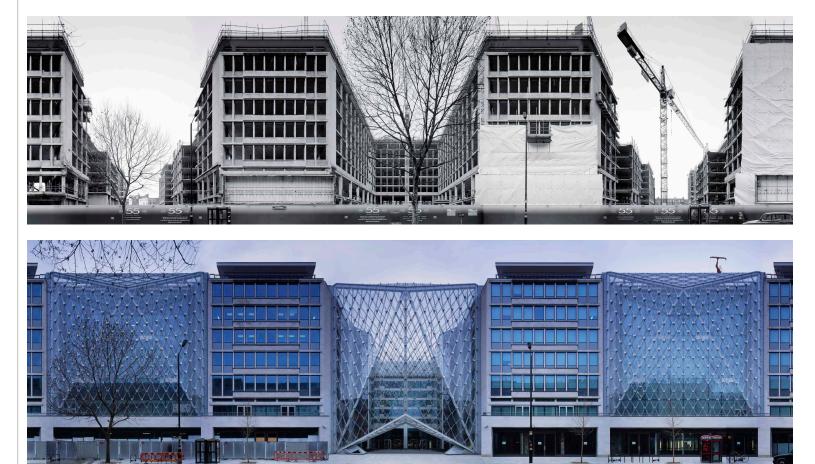
This meant working with the low 2.45m floor-to-soffit height of the old frame. The engineering solution was to propose the thinnest services solution possible, in this case Europe's largest chilled ceiling, which enabled the height taken up by services on each floor to be kept down to a mere 125mm.

The old building's distinctive 'H-block' was transformed into a figure-of-eight design with three seven-storey atria. Around 70% of the original structure was retained, and targeted demolition made way for large expanses of new offices, adding 30% to the original floor area. A grand entrance was required, which was inconsistent with the close-spaced columns of the old building carrying the seven stories above. Expedition's solution was to remove twelve of the reinforced concrete columns at ground level, and replace them with a slim, elegant, angular steel transfer structure which also forms a sculptural feature of the lobby.

Expedition suggested an alternative: since the old reinforced concrete frame was judged to be good quality, why not save as much of it as possible, and build round?

This offered massive potential savings in cost and time (and hence an earlier let and faster pay back), and was a much more sustainable solution. The developer's tender was successful (all the competitors proposed demolition and rebuild) but could the transformation be undertaken without compromising the appeal to potential tenants? See the full project on our website. Images by Make Architects (also featured on the front cover).

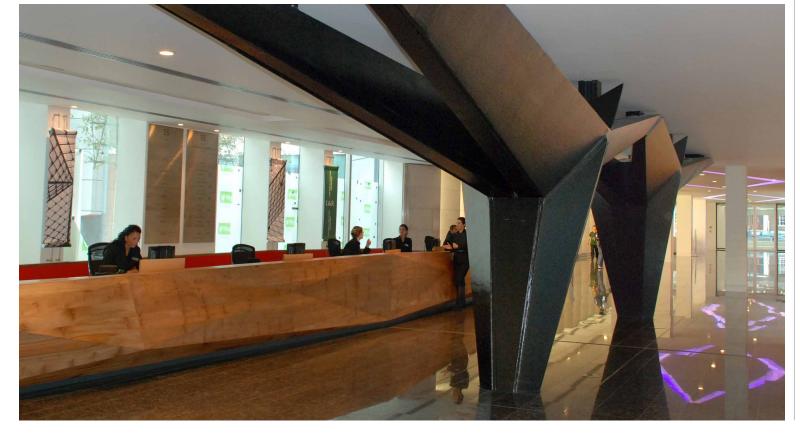
Left: The new steel transfer structure replaced 12 of the original columns and forms a sculptured feature in the entrance lobby.

This meant temporarily propping the concrete structure above, removing the twelve columns, installing the new steel, and then transferring the load onto the transfer structure, which rests on two existing columns at basement level.

Design of the steel transfer structure was not straightforward. It also incorporated sliding bearings borrowed from bridge engineering to maintain the conventional movement joints of the old building at this location.

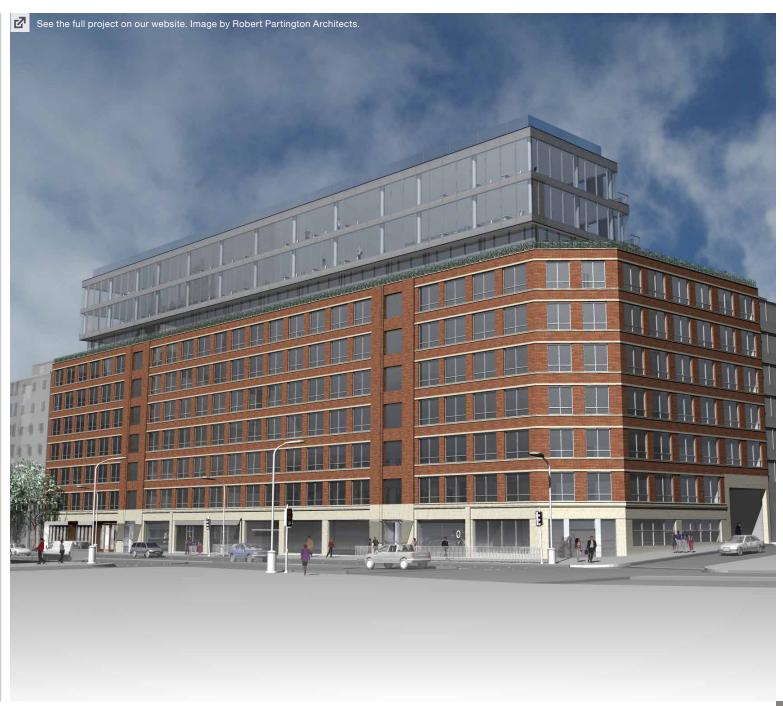
**Right:** Architectural render of Clifton House viewed from Euston Road, showing the three additional floors.

At Clifton House in London's Euston Road, the challenge was to add three floors of grade A office space to an existing seven storey steel structure, built as a warehouse in 1936 and subsequently converted to offices and retail.

Expedition's ingenious solution was to extend and hence increase the capacity of the existing foundations without undermining them – saving time and money – and to demolish the top storey and rebuild four stories, to maximise the value of the building – all while maintaining the ground floor retail throughout.

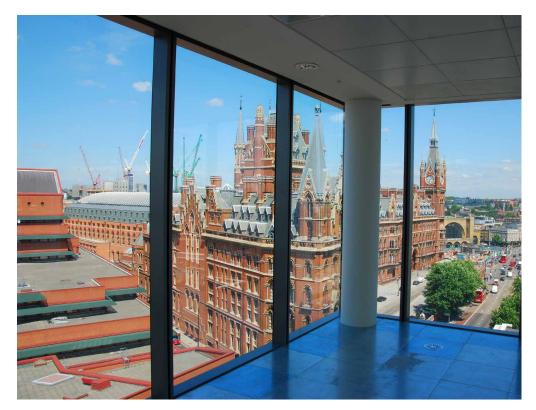
In this case the existing structure did require some strengthening to take the increased lateral loads. This was achieved by a pair of slender and elegant steel pylons forming an architectural feature at the rear of the building.

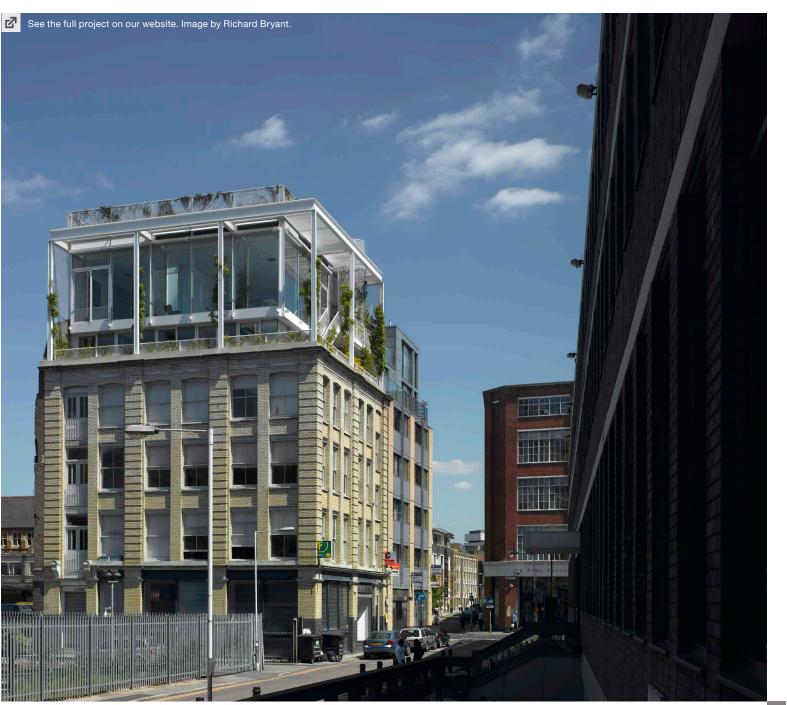
**Right:** The completed extension stands tall above the existing building, allowing some of the best views over London in the area.

The latter – accounting for around 80% of the engineering design work – involved a painstaking assessment of the existing masonry structure and foundations, complicated by evidence of wartime bomb damage.

The new structure added around 10% to the vertical loads but – much more significantly – wind on the new upper storeys added 70% to the lateral loading.

Trial pits round the foundations gave confidence that these could take extra loads, as could the masonry walls: careful checks were done to ensure that the high wind loads would not lead to significant cracking in the masonry.

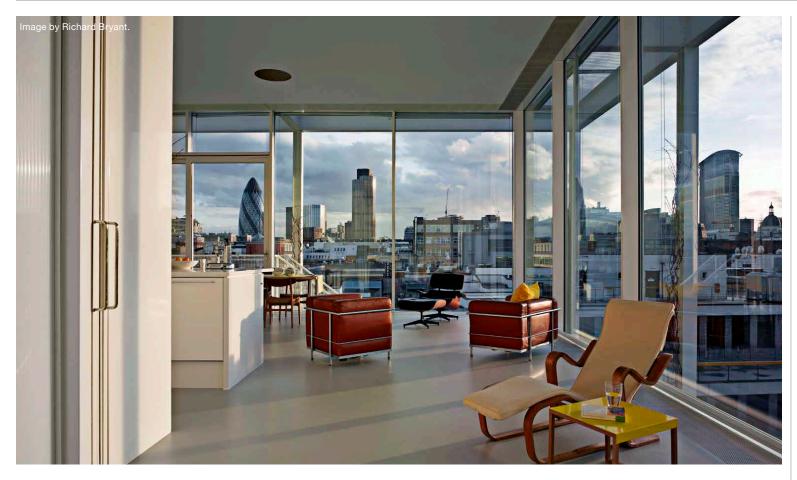
Below: Careful thought of the new structural system was required, oversailing the existing columns and using the exterior masonry walls for support, both for the roof and the mezzanine level.

But the internal cast-iron columns could take no additional load. This meant all the weight of the new apartment had to be transferred to the external masonry piers and walls, and the engineering solution was a new slender steel roof structure supported on equally slender columns resting on the perimeter masonry – with the new intermediate floor suspended from the roof.

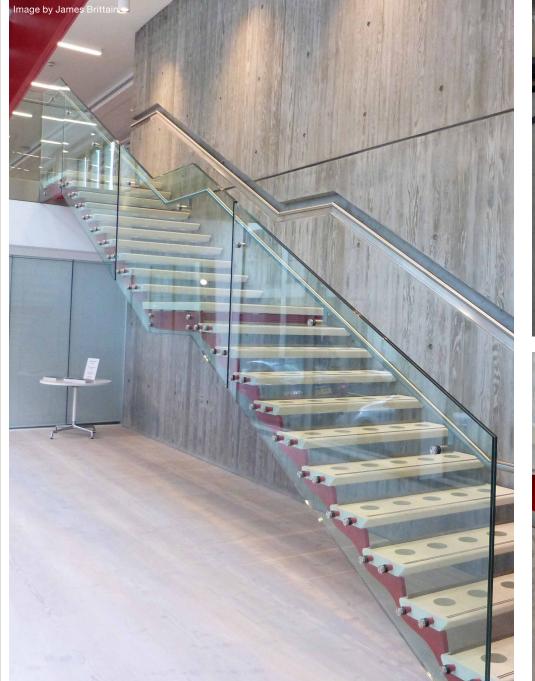
**Right:** The hidden floor and column strengthening work allowed the entrance hall to be formed.

Adjusting the floor system to support heavy book storage and to allow substantial openings for new air ducts and the new atrium involved some novel engineering to keep the works within budget and to avoid impinging on the already tight floor-to-ceiling heights.

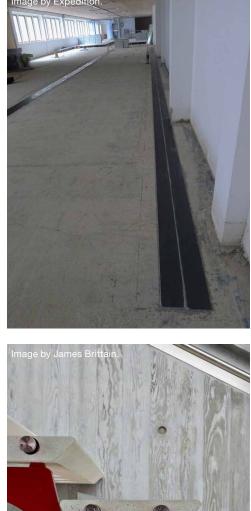
**Top Right:** Carbon fibre floor strengthening hidden in raised floor.

In particular, creation of a two-storey atrium (including the new stair) at the heart of the building required a large opening to be cut in the first floor, which could affect the building's stability: the solution involved bonding carbon-fibre strips to the top and bottom surfaces of the retained sections of floor which effectively reinstated the diaphragm effect of the original floor.
